U.S. DEPARTMENT OF THE INTERIOR

U.S. GEOLOGICAL SURVEY

SURFACE FRACTURES FORMED IN THE POTRERO CANYON, TAPO CANYON, AND MCBEAN PARKWAY AREAS IN ASSOCIATION WITH THE 1994 NORTHRIDGE, CALIFORNIA, EARTHQUAKE

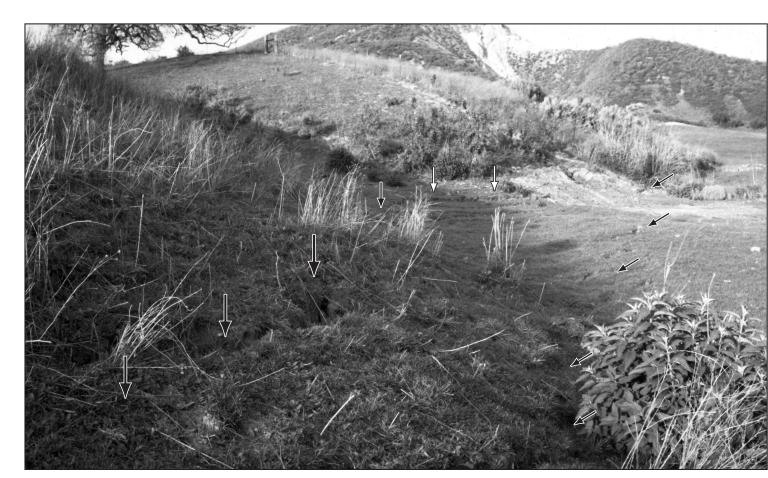
Figure 2. Broad zone of surface fractures, located between vertical and diagonal arrows, on north side of Potrero Canyon. Fractures below vertical white arrows in midground show stair-step pattern indicative of valley fill,

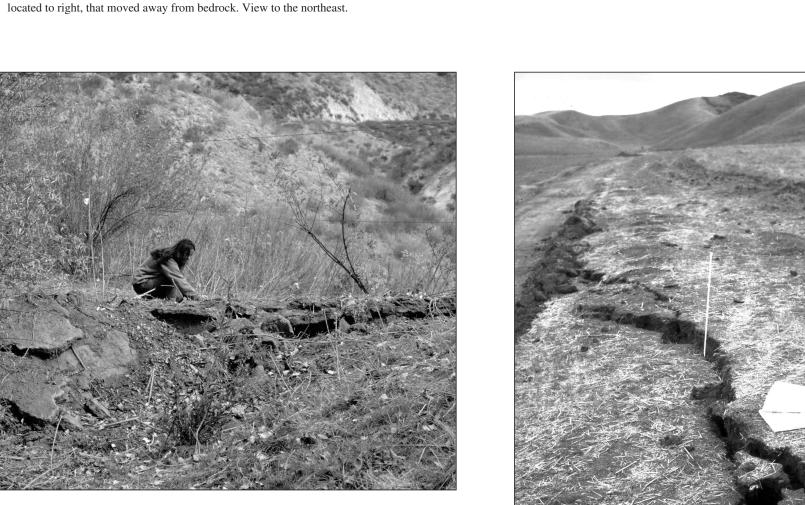
Figure 3. Surface fracture with large vertical component of slip on north side of Potrero Canyon. Fracture developed at base of hillslope, near contact between bedrock and alluvium. View to the northeast.

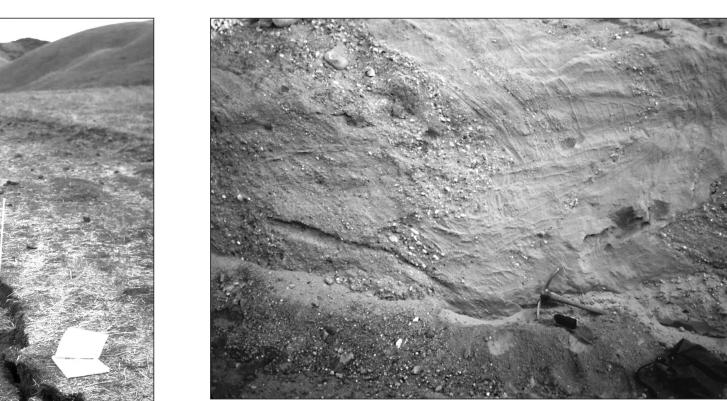
Figure 8. Photograph of trench exposure DC-4, south of Holmes Place (see Map 2 for location and Fig. 7 for log).
